**Flood Control Project Maintenance
Levee Inspections**
LMA District Cover Sheet
Spring 2011 Levee Inspection Results

Reclamation District No. 1500 Sutter Basin

Waterway			Bank	Unit Miles
Unit No. 01 Sacramento River			Left	33.58

Levee Inspection Report By Mile - Spring 2011

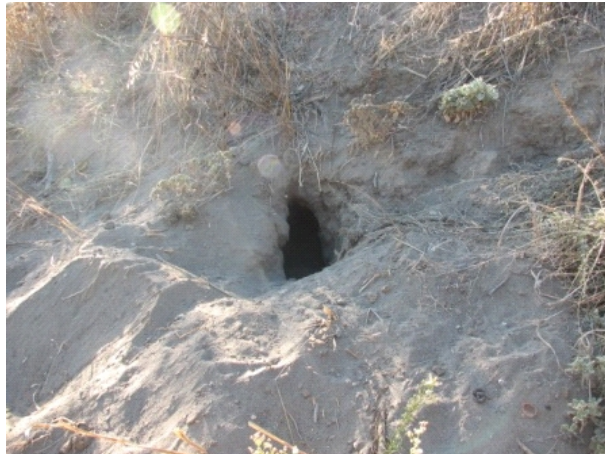
Levee Mile Report Line	5
Start Levee Mile	0.03
End Levee Mile	0.03
Location	Land Side
Category	Earthen Levee
Item	Animal Control
There are multiple rodents hole in the area.	
Johngw_s_20110427_466.jpg

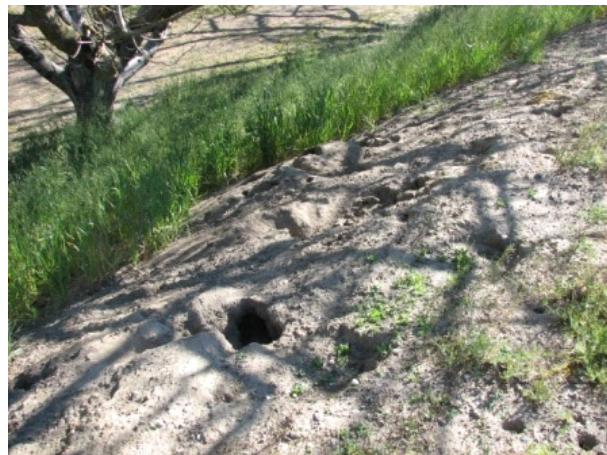
There are some old and a few new rodent holes that need to be backfill.

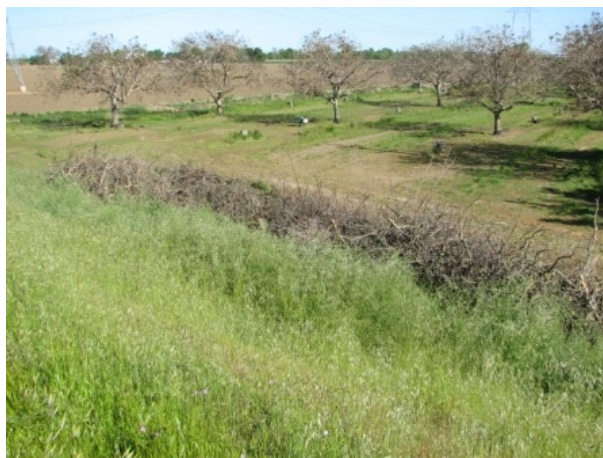
A pile of tree prunings are against the toe of the levee.

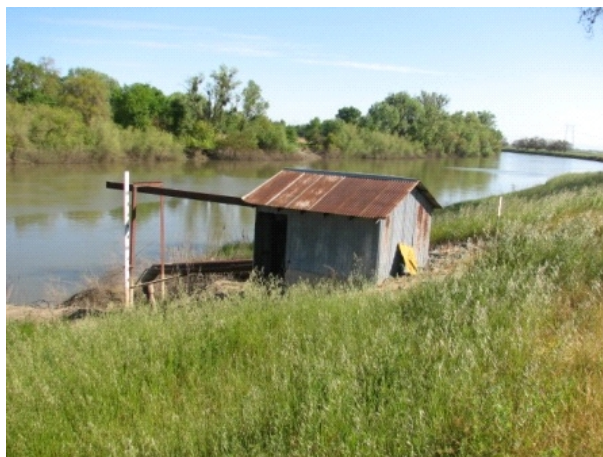
The building is of a pumphouse.

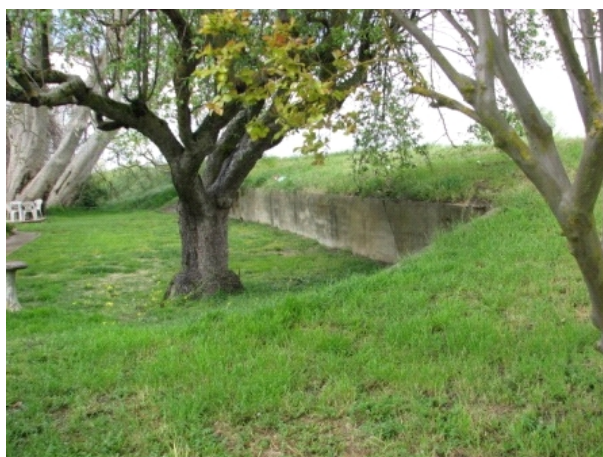
Landscape and retaining wall, this photo is from spring 2010.

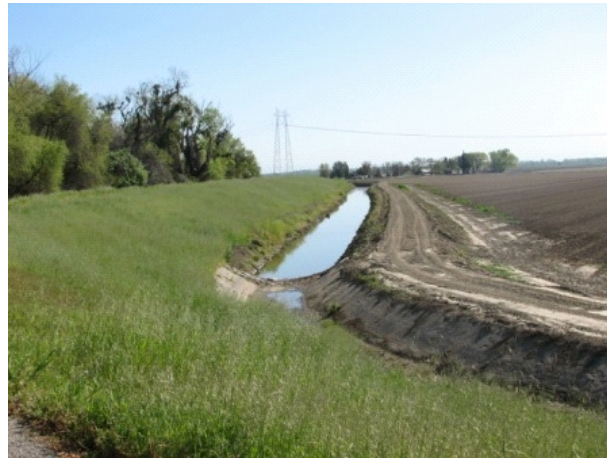
ag. ditch, photo was taken in spring 2010.

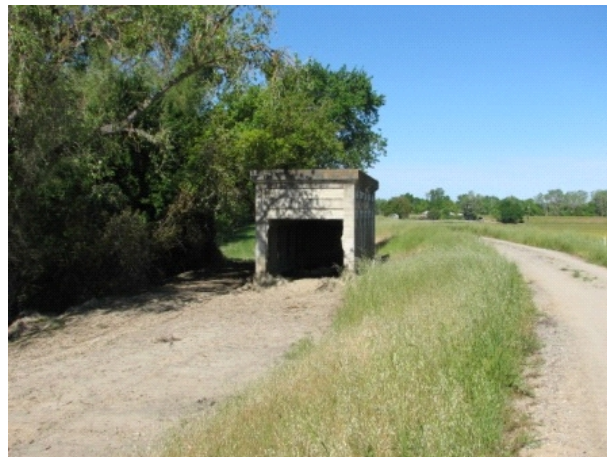
The photo is of the abandoned pumphouse. The district has placed a steel plate over the old outlets. They have began filling the structure for safety.

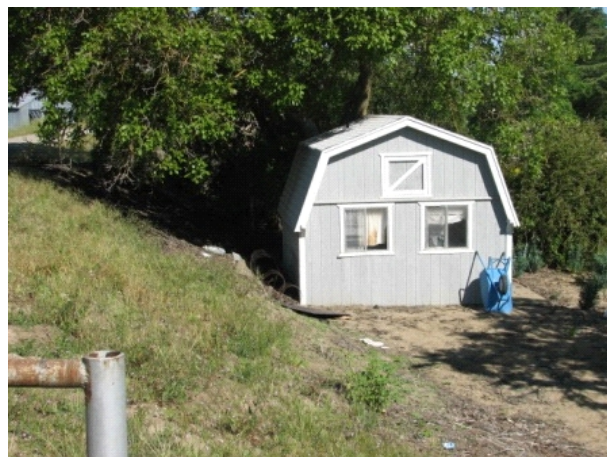
A small building is encroaching into the landside levee toe.

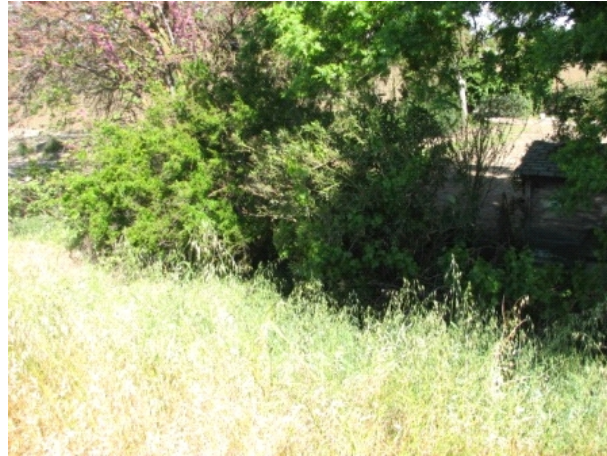
The landscape is planted within the encroachment area of 15'.

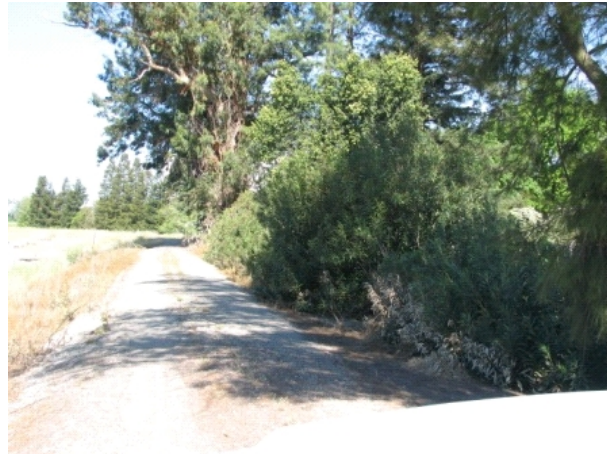
The landscape completely blocks the landside slope and toe.

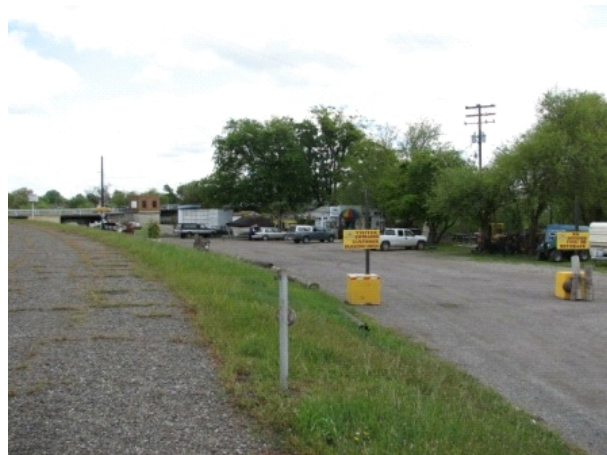
Sting Rays Marina RV park, Photo was taken in spring 2010.

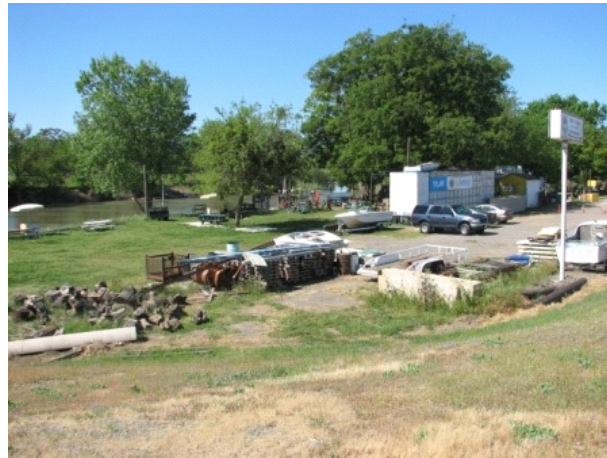
Here is another look at Sting Razs Marina and RV park

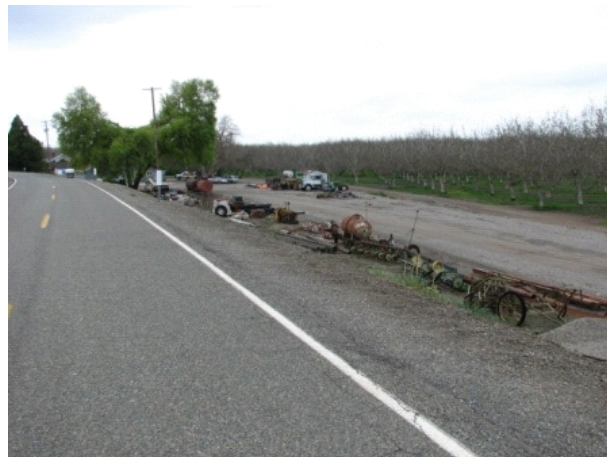
along landside toe, Photo was taken in spring 2010.

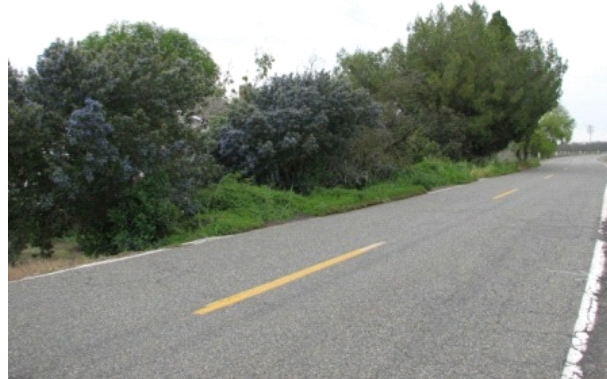
landscape shrubs, Photo was taken in spring 2010.

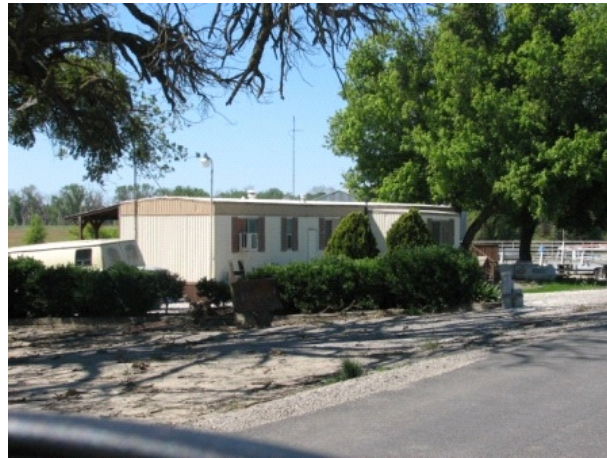
The mobile home is the home of the operator for Sutter Municiple Water.

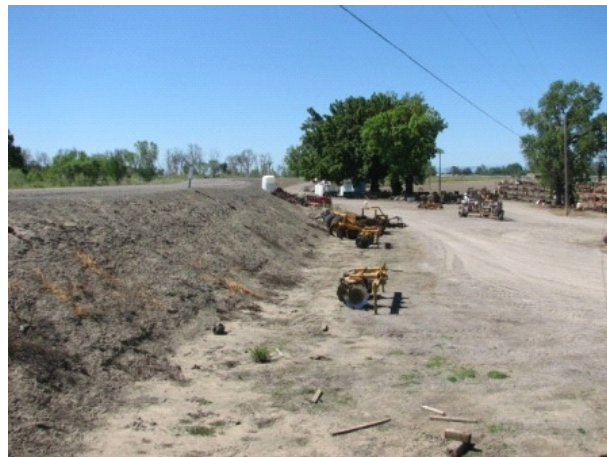
There is equipment parked along the toe of the levee.

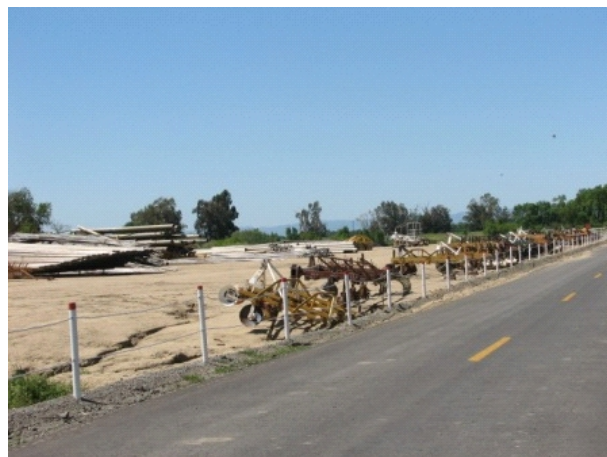
On top of the crown is farm equipment and irrigation pipe.

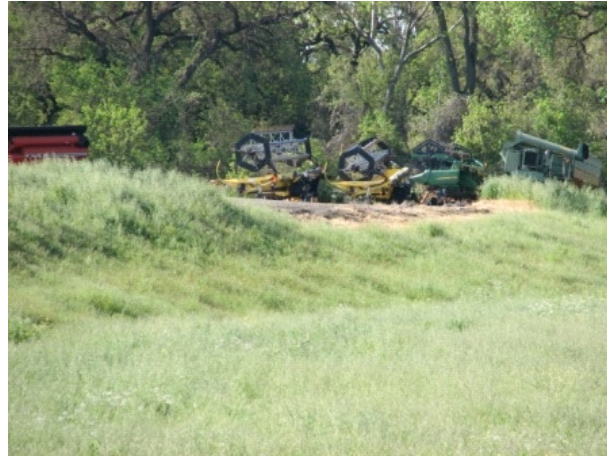
shot of equipment, Photo was taken in spring 2010.

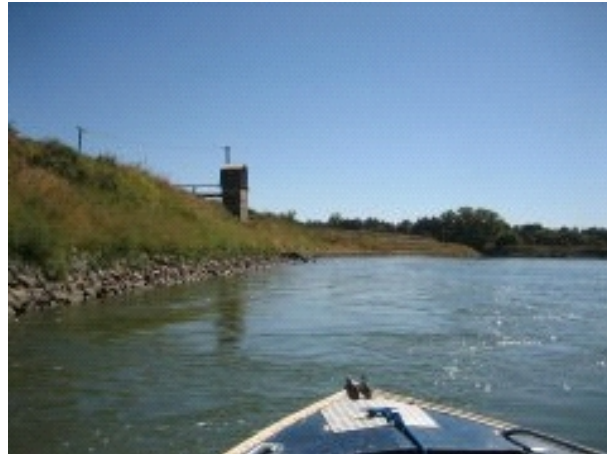
2009: 10 ft berm, 1:1 slope, slumping, sands and silts, 2.72 ft/s [2009 SiteID:SAC_99-0_L]

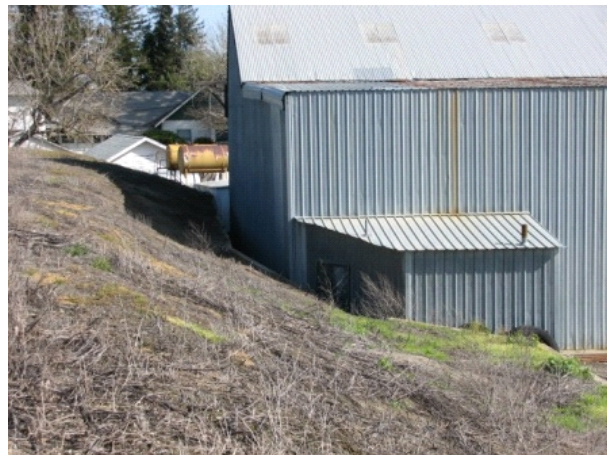
building and wall into levee, Photo was taken in spring 2010.

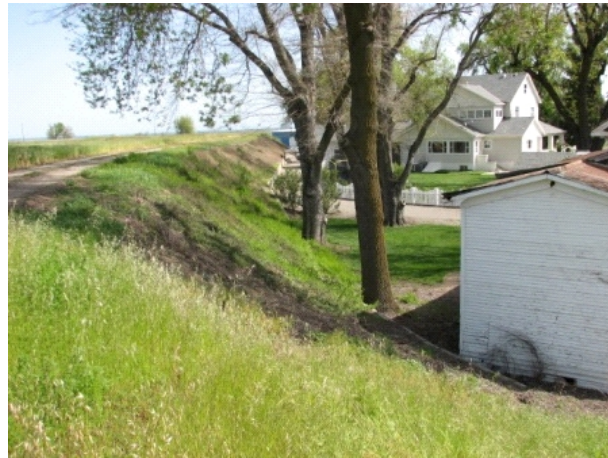
building and wall into levee with landscape, Photo was taken in spring 2010.

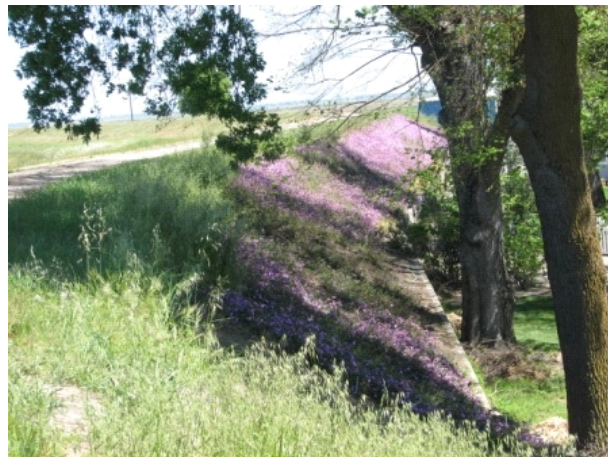
The groundcover is on the levee slope above the concrete retaining wall. The groundcover is irrigated.

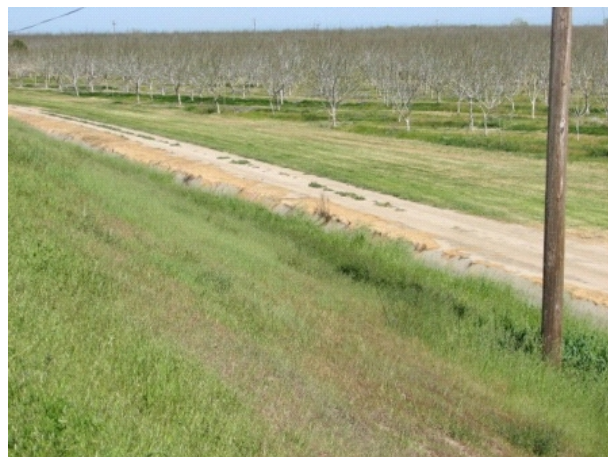
ag. ditch, Photo was taken in spring 2010.

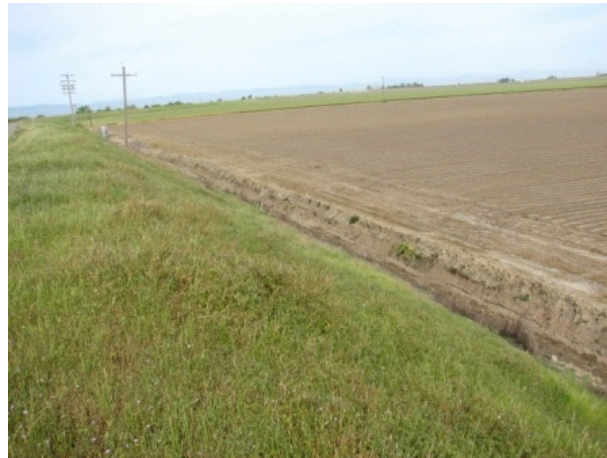
The agricultural ditch run along the toe of the levee.

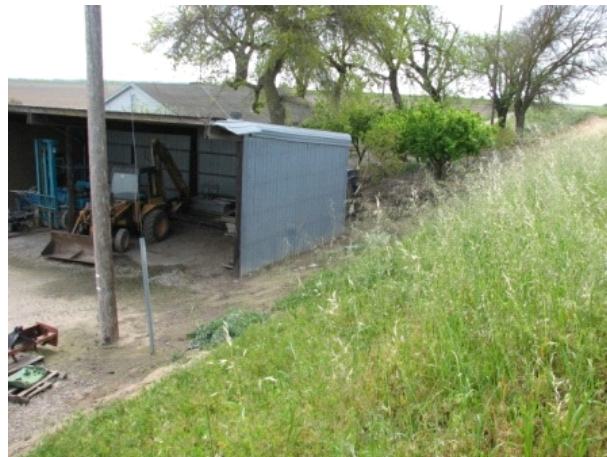
pole barn and some equipment, Photo was taken in spring 2010.

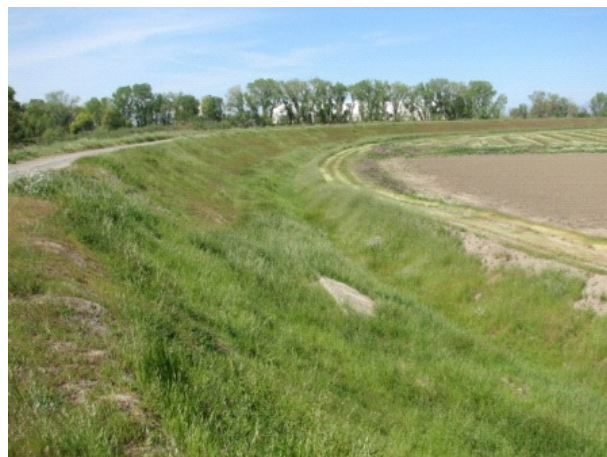
ag. ditch, Photo was taken in spring 2010.

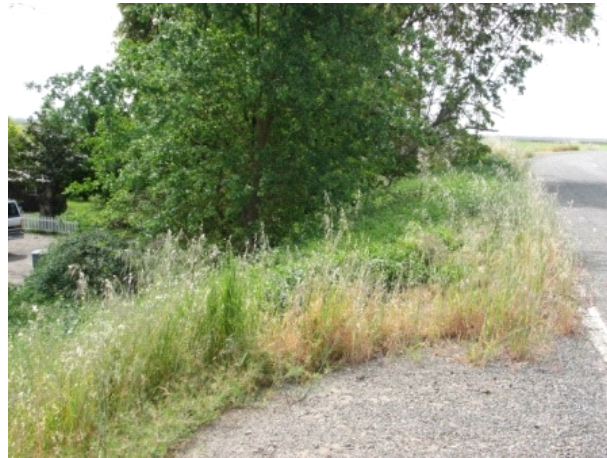
The groundcover in the landscape makes it hard to see the levee slope.

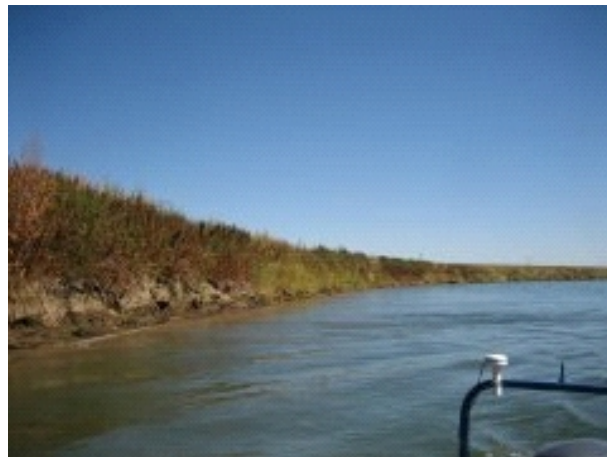
2009: 10 ft berm, 1.5:1 slope, holes and slumping, clays and silts, 4 ft/s [2009 SiteID:SAC_116-5_L]

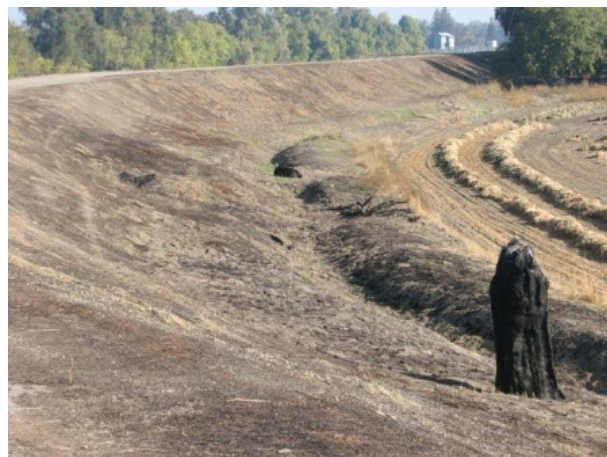
older unused ag ditch stump of tree needs to be removed

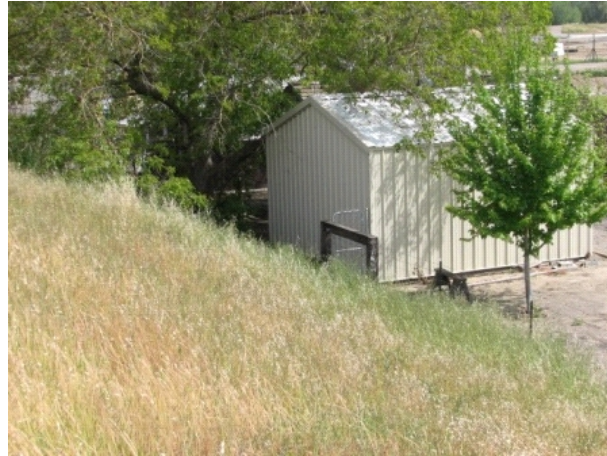
The building is within the easement of the levee toe.

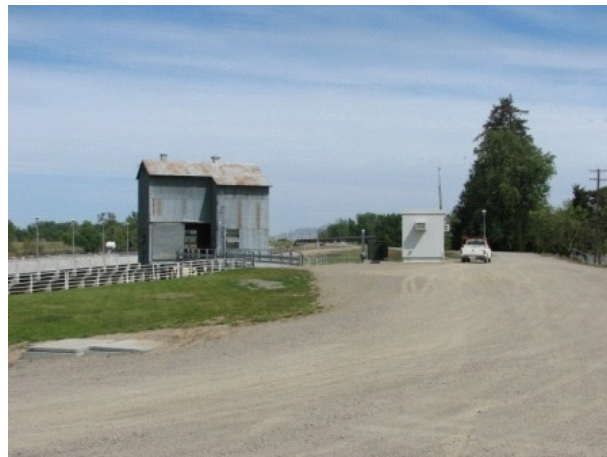
The buildings are on the waterside of the crown. Control buildings for the pumping plant.

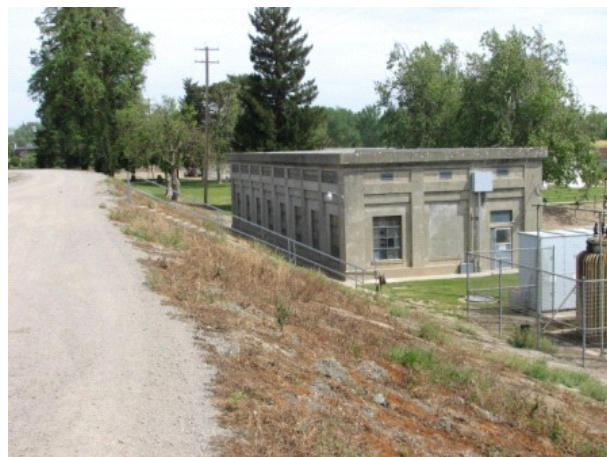
The building is the pumping plant for Sutter Municipal.

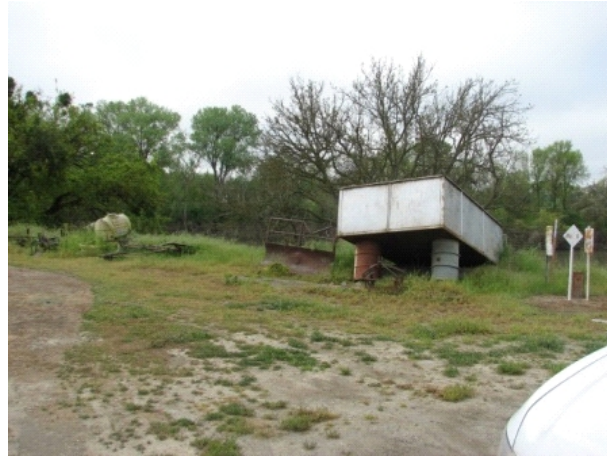
Levee Mile Report Line	1
Start Levee Mile	0.01
End Levee Mile	0.01
Location	Water Side
Category	Earthen Levee
Item	Encroachments
Farm equipment is stored on crown at L.M. 0.0	
johngw_s_20110425_455.jpg

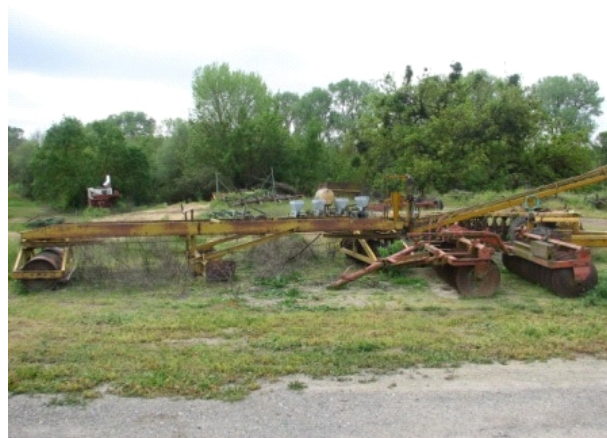
Levee Mile Report Line	1
Start Levee Mile	0.01
End Levee Mile	0.01
Location	Water Side
Category	Earthen Levee
Item	Encroachments
This is another photo of equipment on levee crown.	
johngw_s_20110425_456.jpg

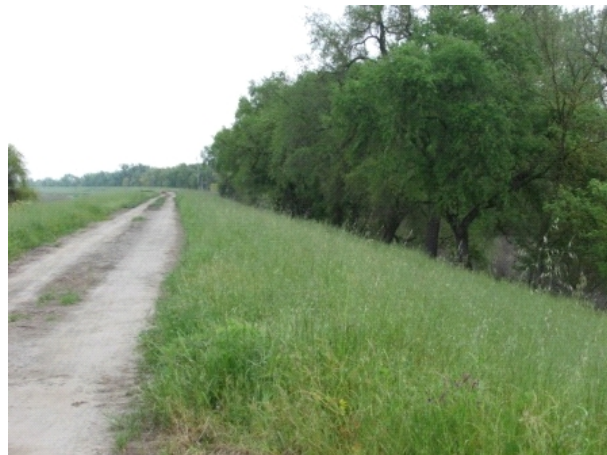
Levee Mile Report Line	2
Start Levee Mile	0.06
End Levee Mile	20.77
Location	Water Side
Category	Earthen Levee
Item	Vegetation
The vegetation grasses is taller then 12" in height.	
johngw_s_20110425_457.jpg

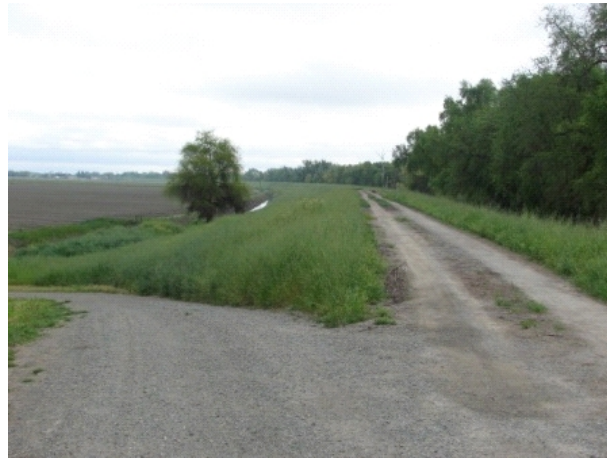
The photo is of the landside vegetation on the levee slope.

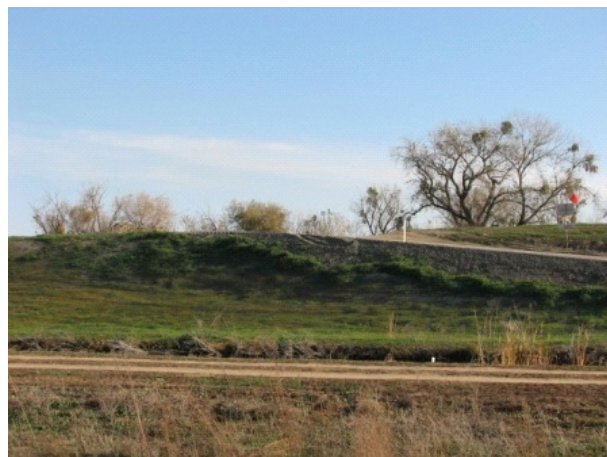
cross view of levee crown

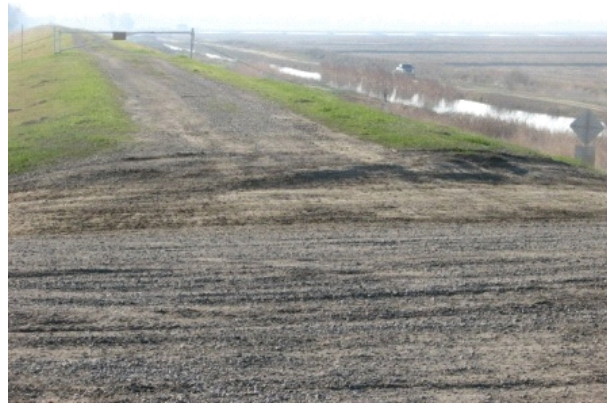
Levee Mile Report Line	8
Start Levee Mile	11.03
End Levee Mile	11.03
Location	Crown
Category	Earthen Levee
Item	Crown Surface / Depressions / Rutting
dip coming off the crown of levee	
johngw_s_20110228_255.jpg

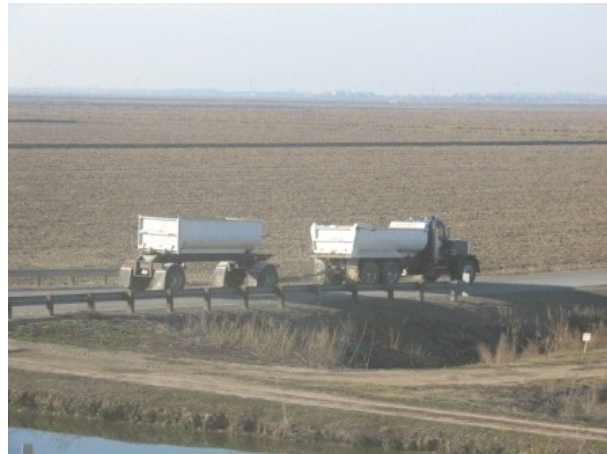
Levee Mile Report Line	8
Start Levee Mile	11.03
End Levee Mile	11.03
Location	Crown
Category	Earthen Levee
Item	Crown Surface / Depressions / Rutting
typical truck that crosses the levee	
johngw_s_20110228_256.jpg

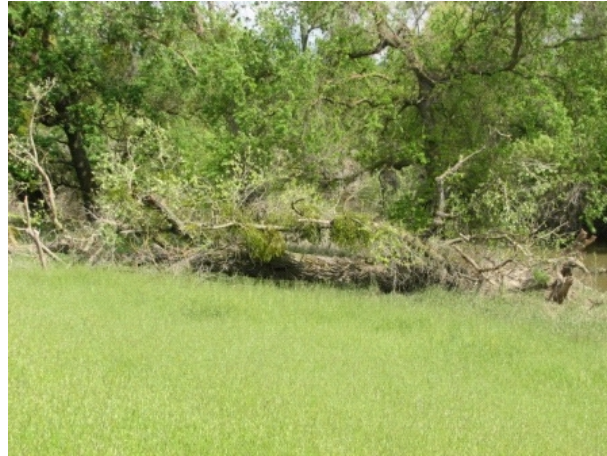
johngw_s_20110425_461.jpg

The photo shows a fallen tree on the waterside that is up rooted.
